UNDERWATER FACILITIES  
INSPECTION &  
ASSESSMENTS  
NAVAL STATION CHARLESTON, SC.

The objective of the underwater facility assessments conducted at the U.S. Naval Station in Charleston, South Carolina is to provide a generalized structural condition report of designated facilities within the activity.

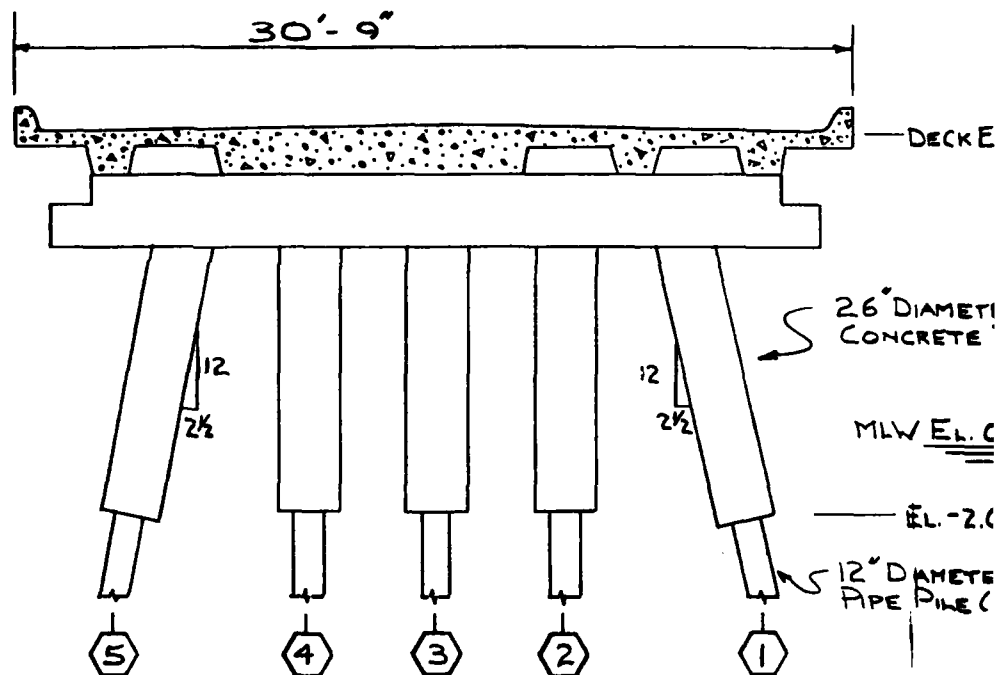
The only damage observed occurred in Bent 2. The concrete jacket on Pile 1 had a 1/2" wide horizontal crack around its circumference, 6 feet below the pile cap. There were no other signs of damage. An 18" square concrete pile had been driven just south of and adjacent to Pile 1 (see Figure 17).
